Article

# Effect of Implantoplasty on Roughness, Fatigue and Corrosion Behavior of Narrow Diameter Dental Implants

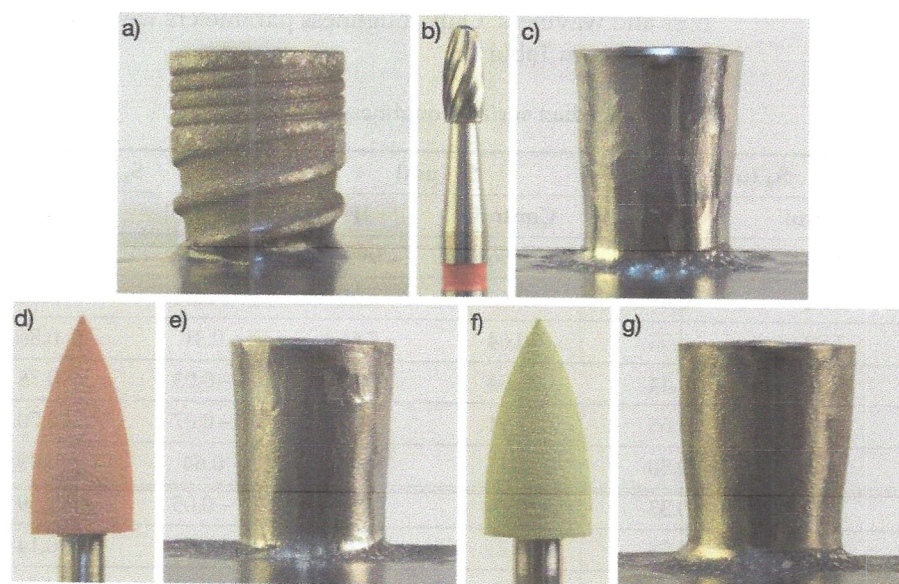
**Figure 2.** Simplified three-bur protocol IP procedure. (a) Macroscopic appearance of the implant; (b) Tungsten carbide bur; (c) Macroscopic appearance of the implant after applying the tungsten carbide bur; (d) Brown silicon carbide polisher; (e) Macroscopic appearance of the implant after applying the brown silicon carbide polisher; (f) Green silicon carbide polisher; (g) Macroscopic appearance of the implant after applying the green silicon carbide polisher.

Implantoplasty was performed following the simplified three-bur protocol described by Costa-Berenguer et al. [19]. We inserted a cover screw to protect the implant connection from titanium debris and removed the threads of the coronal half of the implants using an oval-shaped tungsten carbide bur (H379.314.023 Komet, GmbH and Co. KG, Lemgo, Germany) with an air-driven high-speed handpiece under water irrigation. We instructed the operator to limit the initial steps of implantoplasty to the threads of the dental implant, as recommended by Schwarz et al. [12]. Then, we polished the resulting surface with two silicon carbide polishers and the same handpiece (9618.314.030 and 9608.314.030 Komet, GmbH and Co. KG, Lemgo, Germany) (Figure 2).

Implantoplasty was performed on two consecutive days by an experienced clinician (O.C-F.) that had been involved in previous studies with a similar design. Magnification loupes ( $2.8\times$ ) with a LED light (Galilean HD and Focus™ LED 6000 k, ExamVision ApS, Samsø, Denmark) were used and implantoplasty was conducted until the 5-mm coronal portion of the implant exhibited a uniformly smooth and shiny surface. The pressure applied and the number of strokes was not standardized in order to increase the external validity of the study. A new set of burs or tips was used for every other implant. After IP, the implants were thoroughly cleaned by irrigation using distilled water and dried with compressed air. Finally, the cover screw was removed.

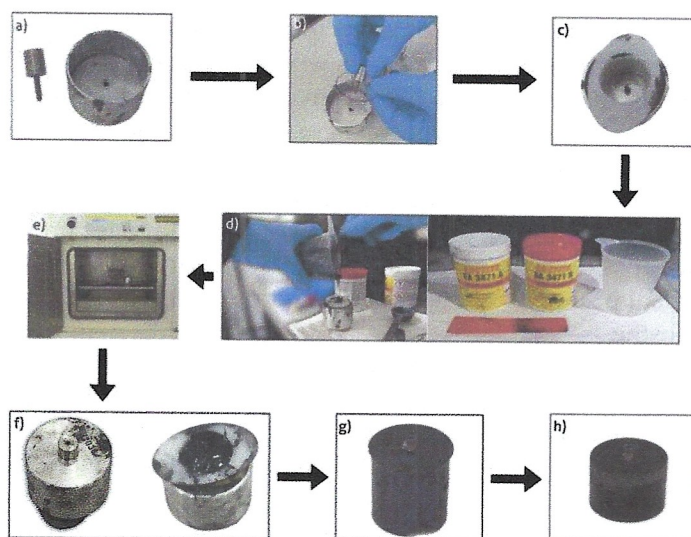
**Figure 3.** Process of making the study specimens. (a) Holding the implant in the cartridge. Metal tray; (b) Insertion of the implant in the tray and placement of the separator; (c) Placement of the plastic mould; (d) Mixing of epoxy resins; (e) Baked; (f) Specimen once baked; (g) Unmoulded; (h) Standardization of dimensions.

In a second step, we embedded the implants in the same position using resin casts, in such a way that 5 mm of the rough surface was exposed. This approach was chosen to simulate horizontal bone resorption of 5 mm (50% of the total implant length), which is 2 mm more than the International Standardization Organization (ISO) 14801:2016 specifications. The epoxy resin was EA 3471 A and B Loctite® (Henkel AG and Company, Düsseldorf, Germany) to simulate bone (Young's modulus of elasticity  $\geq 3$  GPa). In Figure 3 can be observed the preparation of the samples.

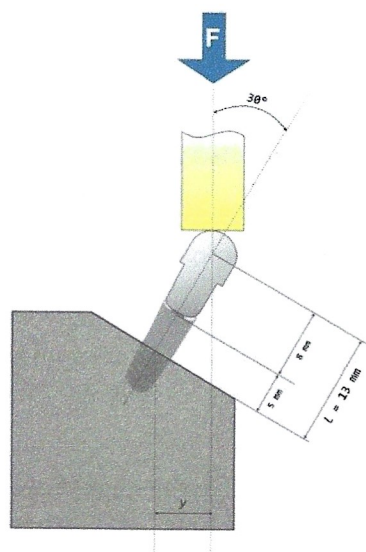
**Figure 4.** Schematic representation of the test setup according to ISO 14801:2016, except for bone nominal level.

We carried out fatigue testing in room air and at room temperature using a servo-hydraulic mechanical testing machine (MTS Bionix 370, MTS®, Eden Prairie, MN, USA) equipped with a 15 kN load cell (MTS Load Cell 661.19H-03, MTS®, Eden Prairie, MN, USA). We screwed identical hemispherical abutments to each implant with the torque recommended by the manufacturer (35 N·cm). The loading center was located 13 mm above the resin (nominal bone level). According to ISO 14801:2016, we placed the samples in a stainless-steel clamping jaw so that loading had an angle of 30° to the longitudinal axis of the implant (Figure 4).

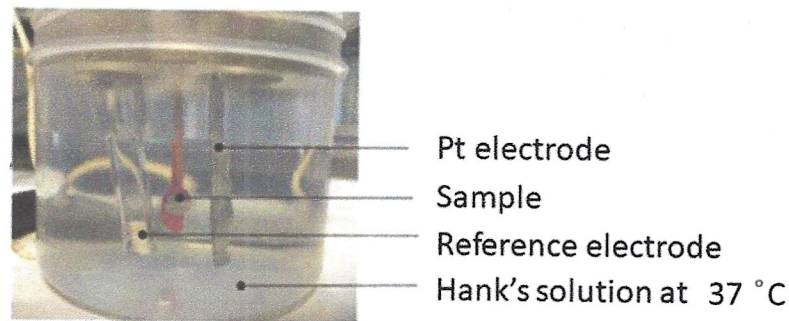
**Figure 5.** Experimental setup used for assessing corrosion resistance.

The electrochemical cell used can be observed in Figure 5. For both the open circuit potential and the potentiodynamic tests, the reference electrode used was a calomel electrode (saturated KCl), with a potential of 0.241 V. All tests were performed at 37 °C inside a Faraday box to inhibit the external electric or electromagnetic fields.

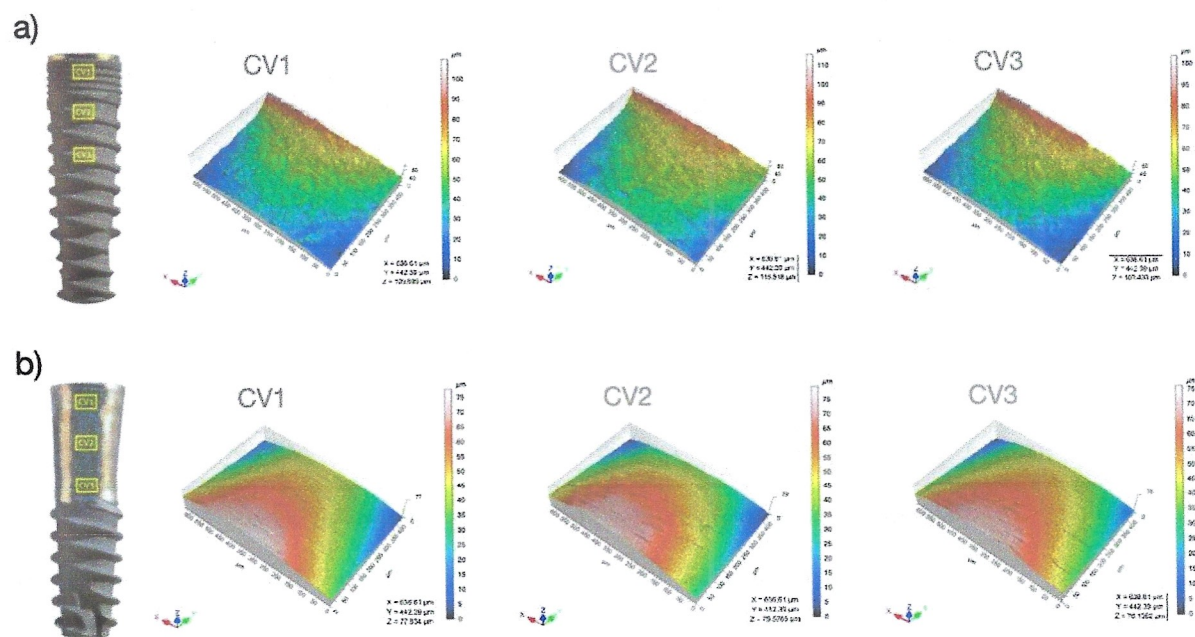
**Figure 6.** Confocal microscope 3D surface topography analyses of the control (a) and experimental samples (b) for each of the three regions of interest (CV1–3).

The surface topography results are shown in Table 2. The median  $S_a$  (arithmetic mean height),  $S_z$  (average maximum height),  $S_{sk}$  (skewness of topography height distribution), and  $S_{dr}$  (developed interfacial area ratio) values of the IP group were significantly lower than those of the control group ( $p \leq 0.001$ ) (Table 2). In the treated surfaces, the roughness of the coronal, middle, and apical areas was similar and no statistically significant differences were found in any of the parameters ( $S_a$ ,  $S_z$ ,  $S_{sk}$ , and  $S_{dr}$ ). Representative confocal microscope 3D topography images of the control and experimental samples for each of the three regions of interest (T0, T2.5 and T5) are depicted in Figure 6.

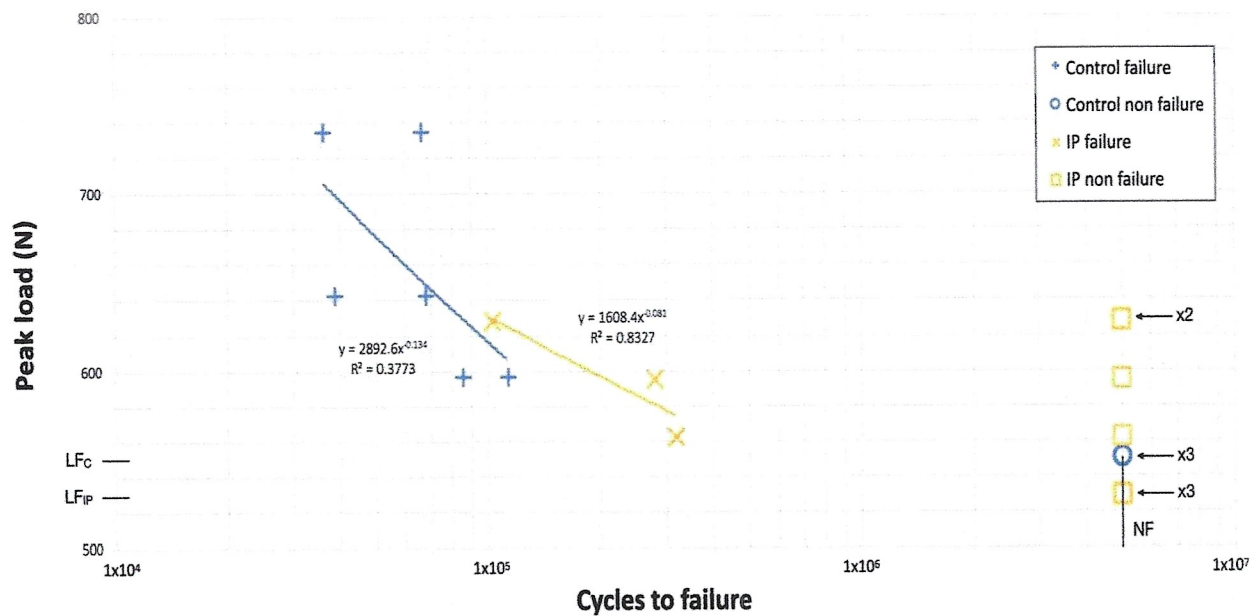
**Figure 7.** Load versus the number of cycles plot (S-N curve) for each group.

Load versus the number of cycles (S-N curves) in the IP and control groups is represented in Figure 7. Two different regions could be identified: (1) the finite life region was found above 551 N (i.e., 60% of F<sub>maxC</sub>); and (2) the infinite life range which started below that threshold. Similarly, in the load versus the number of cycles plot obtained for the IP samples (Figure 7), we determined: (1) a transition region above 529 N (i.e., 80% of F<sub>maxIP</sub>); and (2) an infinite life range that started below that threshold.

In the present study, six control implants fractured, whereas only three implants with implantoplasty did not withstand the  $5 \times 10^6$  loading cycles. This finding could be explained by the fact that the control samples were submitted to higher initial loading levels in comparison with the experimental implants (735 N vs. 529 N), according to the results of the previously performed static load tests 31. Hence, monotonic loading seems to have a reduced clinical relevance as mechanical failures are more likely after the application of repeated loads [53]. It should be also stressed that, according to Shemtov-Yona et al. [54], narrow implants have shown an unpredictable fatigue behavior. In this sense, only two different regions could be identified in the S-N curves (Figure 7)

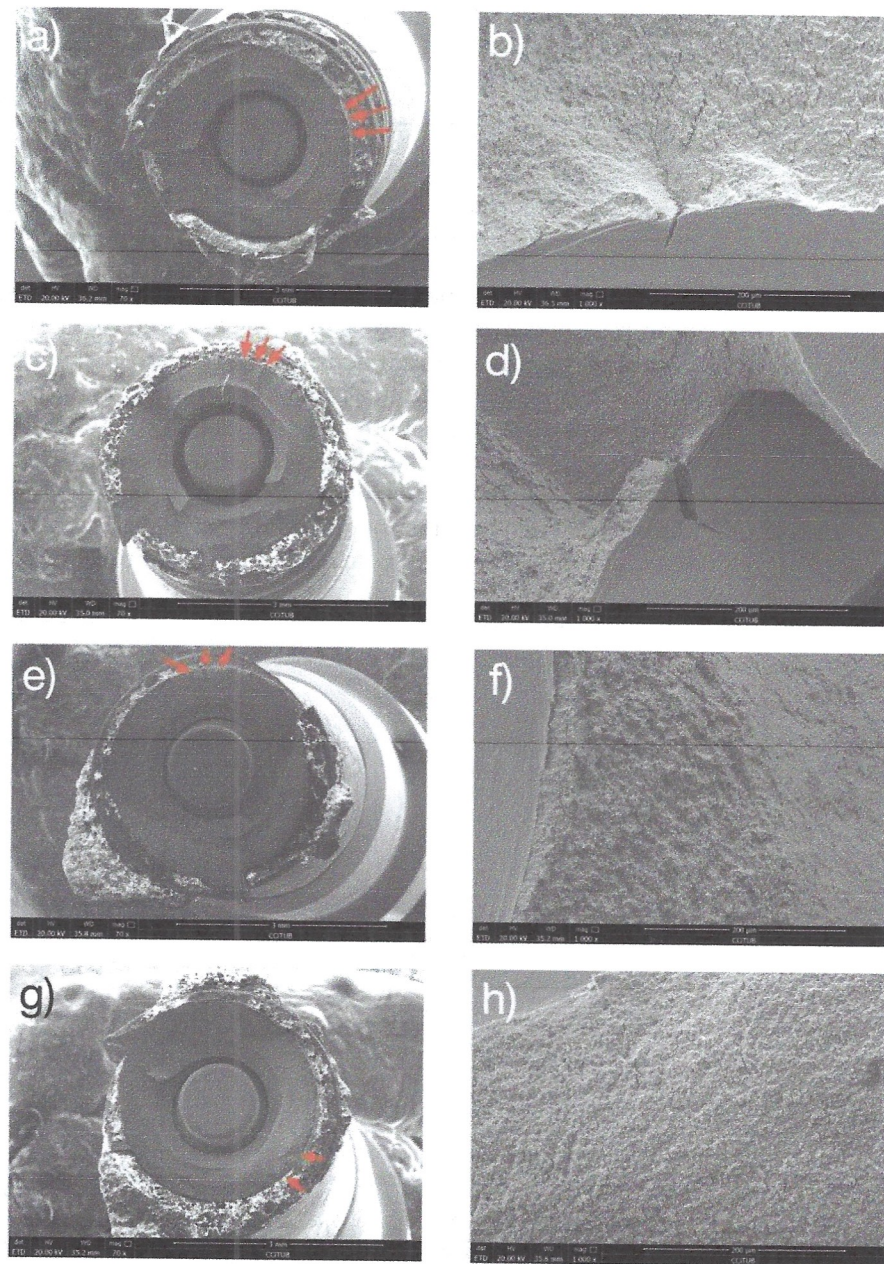
**Figure 8.** Fractographic analysis with scanning electron microscopy. (a–d) Control samples, a and c are macroscopic aspect of the fractured dental implants where the red arrows indicate the crack nucleation in the implant surface. b and d are the images at more magnification of a and c where can be observed the crack and the secondary cracks and their propagation. (e–h) Test samples. e and g are macroscopic images where the red arrows indicate the crack nucleation. f and h are image of the fracture surface where can be observed the ductility of the titanium.

All failed samples exhibited a fracture pattern perpendicular to the longitudinal axis of the implant in a region of the implant body close to the embedding plane (Table 3). This area is the least thick zone, due to the presence of the hollow space for the prosthetic screw.

The micrographic analysis of the fracture surface revealed a typical brittle intergranular fracture mechanism with secondary cracking. In all cases, fatigue failures started at the implant body. More specifically, the fracture began on the side of the implant subjected to continuous and oscillating stresses. Accumulated damage led to rupture on exceeding the mechanical resistance of the material (Figure 8). Fatigue cracks are always nucleated on the surface of the dental implant, as can be seen in Figure 8. The location of the breakage is at the screw connection as can be seen since this is the area with the smallest cross-section of the dental implant. The area that is observed smoother is the area of crack propagation and subsequently the ductile fracture of the material since the resistant section is reduced as the crack progresses.

The fractographic analysis revealed a classical fatigue failure pattern, with the presence of fatigue striations, perpendicular to the fatigue crack direction, in all fractured specimens. The scanning electron microscope (SEM) images are consistent with the results obtained in clinical studies that analyze implant fractures [58]. As expected, the most susceptible area to fracture was the implant body near the embedding plane probably due to the presence

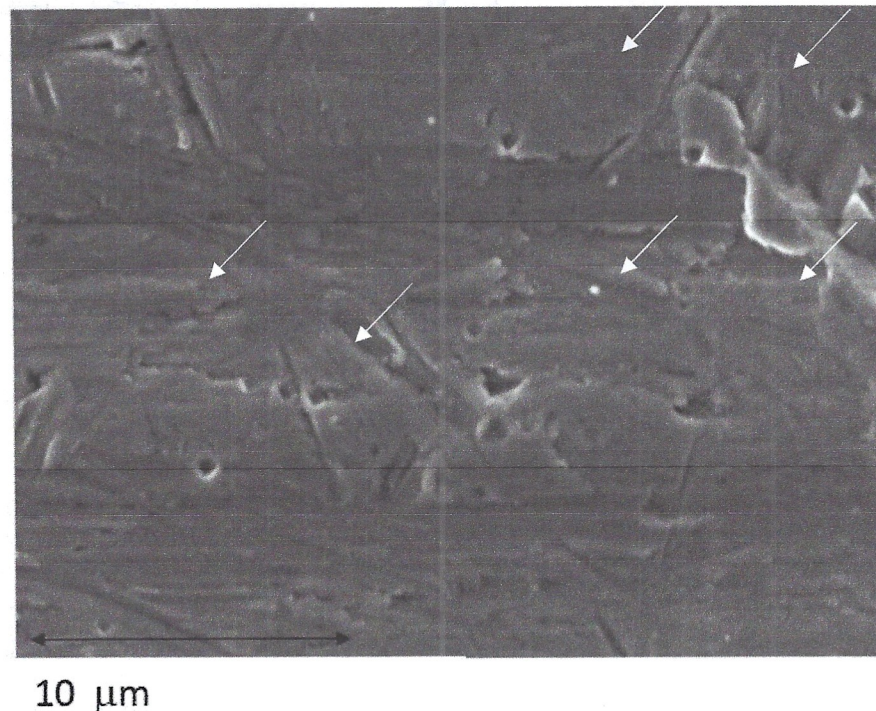
**Figure 9.** Pitting observed by SEM in the interface smooth-roughness of the dental implant treated. (Arrows show the pitting in the titanium).

The potentiodynamic analysis confirmed that the treatment that produced surfaces with the best corrosion resistance was as-received dental implants showing the lowest values of corrosion current density ( $i_{\text{corr}}$ ) and corrosion rate ( $V_c$ ). In addition, the original implants show the highest resistance to polarization ( $R_p$ ). Implantoplasty produce a loss of the corrosion resistance with respect to the as-received samples. Figure 9 shows pitting in the interface area of the rough part of the dental implant and in the smoother area. This is the zone of the greatest potential difference generated by the differences in internal stress of the material between the rough and the machined part. It is well known that the energetic heterogeneities on the surface are points susceptible to corrosion [27,28].
